### **HCAT PROJECT**

# FUNCTIONAL ROD/SEAL TESTING AND QUALIFICATION OF HVOF COATINGS ON NAVY ACTUATORS

NAS Patuxent River, MD

March 16, 2005 HCAT

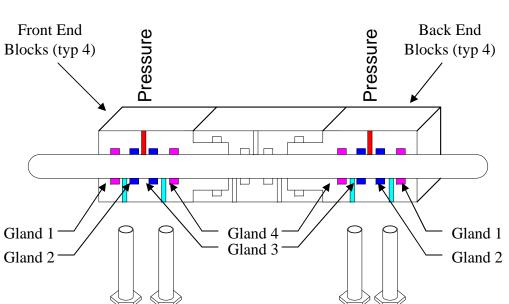
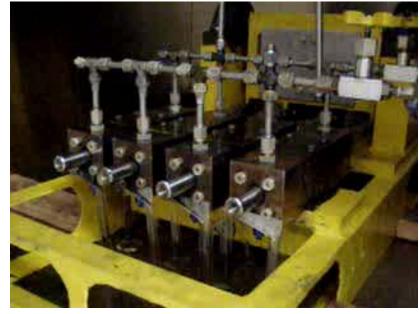
## **Test Rod and Seal Layout**

• There are two seal configurations per block and two blocks per rod so that 16 rod/seal configurations are being evaluated per test.

• Primary (test seals) indicated in blue and the secondary (scraper seals) in

magenta. Primary and secondary seals are similar.

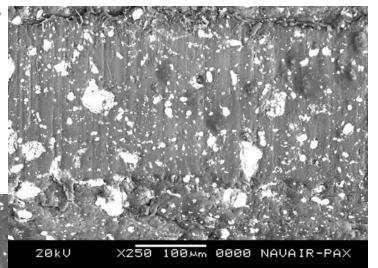
SEM Axial Scratches

PTFE Cap Seal

(FS O-ring/PTFE Cap)

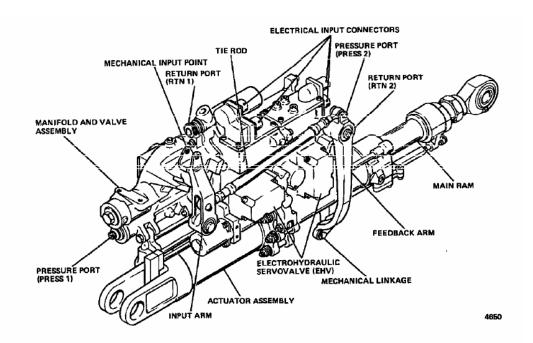
## F/A-18 C/D Stabilator Actuator Continued

- STAB actuator testing is complete and report is finalized by NAVAIR.
- ECP-950 validation is complete. Verification (reviewing component process procedure) has not been performed. Currently have seal kits and are awaiting installation tooling. This will be done at JAX.

### F/A-18 C/D Stabilator Actuator

- Based on laboratory results, fluorocarbon static seals and PTFE spring energized dynamic seals in primary and secondary glands were selected.
- Rebuild kits for F/A-18 C/D stabilator actuator were developed by three seal vendors using hardware dimensions.
- Seal kits showed no external leakage and acceptable internal leakage after endurance testing. Post-test leakage was within ATP limits.
- Follow-on testing evaluated HVOF coated rod against these seals.
  - HVOF Coat short external end with WC/Co/Cr 86/10/4
  - HVOF Coat longer internal end with WC/Co 83/17
  - Ground to 8 16  $\mu$ in Ra finish and superfinish to  $\leq 2 \mu$ in Ra finish
- Leakage performance was equivalent to chrome plated rod.

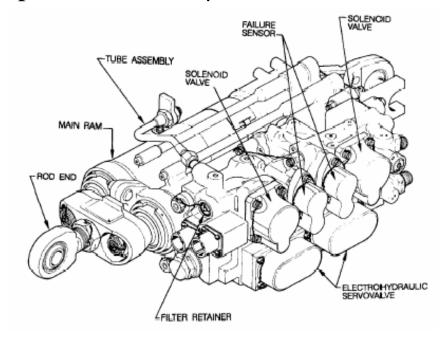
## F/A-18 C/D Trailing Edge Flap

- Same dynamic and static seal materials used for TEF as proven on STAB.
- Side by side design allows one chrome rod and one HVOF rod to evaluate seals against both rod surfaces.
  - HVOF Coat OD of Piston Rod with WC/Co/Cr 86/10/4
  - Ground to 8 16  $\mu$ in Ra finish and superfinish to  $\leq 2 \mu$ in Ra finish
- Endurance testing of TEF is complete and report is currently being written.
- ECP validation and verification is not complete. Awaiting seal kits at NADEP North Island.

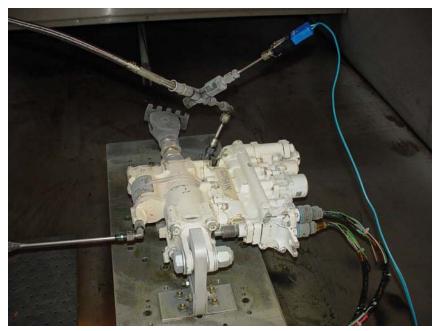
## F/A-18 C/D Rudder and Aileron

- End gland for the chrome piston rod have a SE PTFE in the primary gland. The secondary gland is an o-ring with PTFE capstrip.
- Testing began this week at PAX.
- Seal upgrade may need further delta testing with HVOF coated rod qualification or similarity qualification may be acceptable with analysis.
